NATIONAL TRANSPORTATION SAFETY BOARD

ON-SCENE and EXAMINATION INFORMATION

**NTSB Accident: WPR17FA013
Accident Date: October 25, 2016**

Location: Pittsburg, California
Date: October 25, 2016
Aircraft: Beechcraft A36 'Bonanza', N364RM, Serial # E-2957
NTSB IIC: Michael Huhn

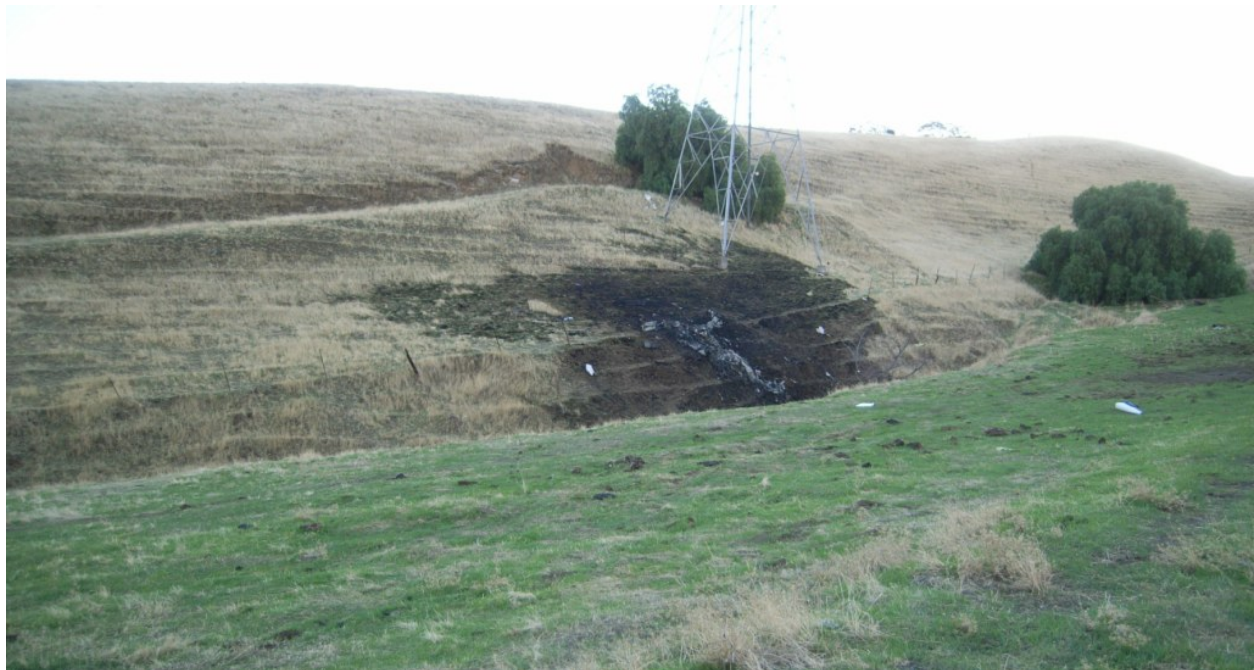
Figure 3 - View with Impact Site (Note components in foreground)

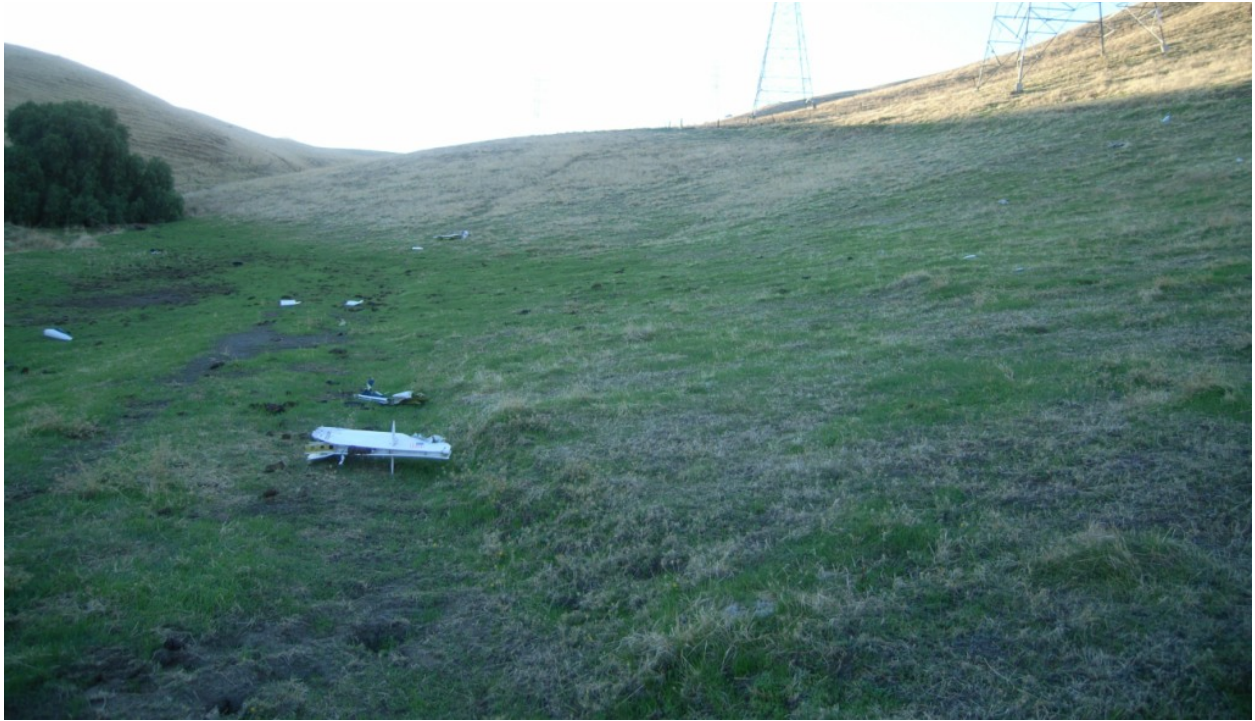
Figure 4 - View Across Wreckage Path

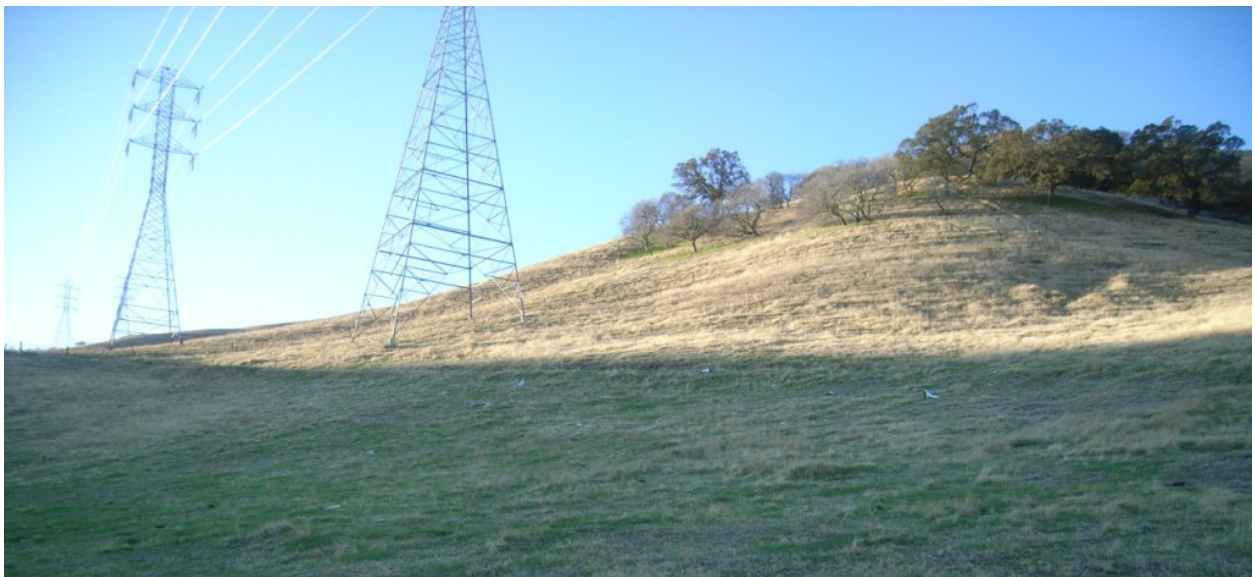
Figure 5 - View with Powerline-separated Components

- About 50 powerline-strike separated parts were situated on the ground between the powerline strike location and the main wreckage
- The parts were catalogued in a database and then recovered
- The parts were re-assembled in a 2-D layout at the recovery facility
- Refer to separate documents in the NTSB public docket for detailed information regarding the parts database and also the 2-D layout and exam results

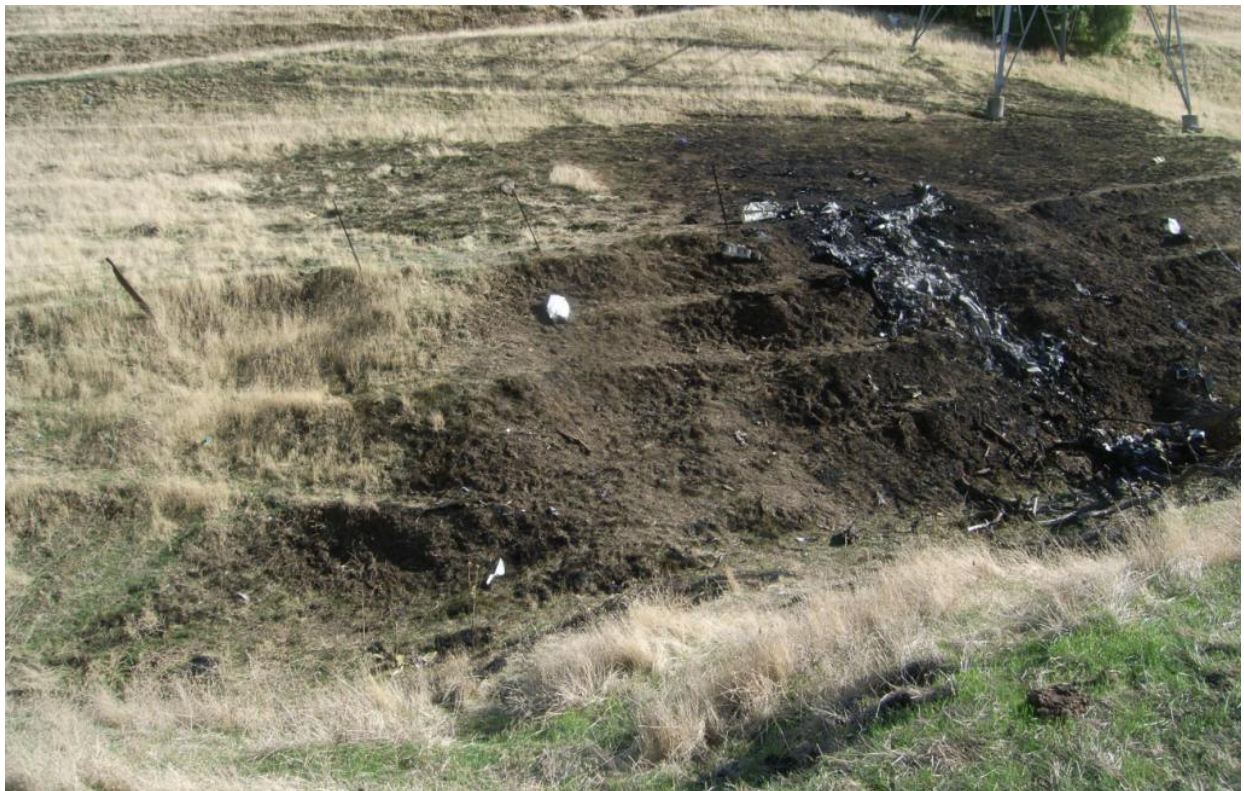
Figure 7 - Impact Site and Wreckage

- The wreckage was situated on steeply-sloping terrain on the northwest side face of a ravine
- A ground fire consumed much of the airplane, and spread to the dried grass that was present at the impact site. The affected/burned grass extended irregularly about 25 to 50 feet beyond the main wreckage
- Ground scar and wreckage distribution were consistent with the airplane striking the ground in a relatively steep trajectory, approximately perpendicular to the ravine face
 - The overall main wreckage distribution was generally consistent with the airplane coming to rest inverted, from a nose-over during/after impact
 - The ravine was approximately 25 feet deep, with walls that sloped between about 25 and 45 degrees from the horizontal

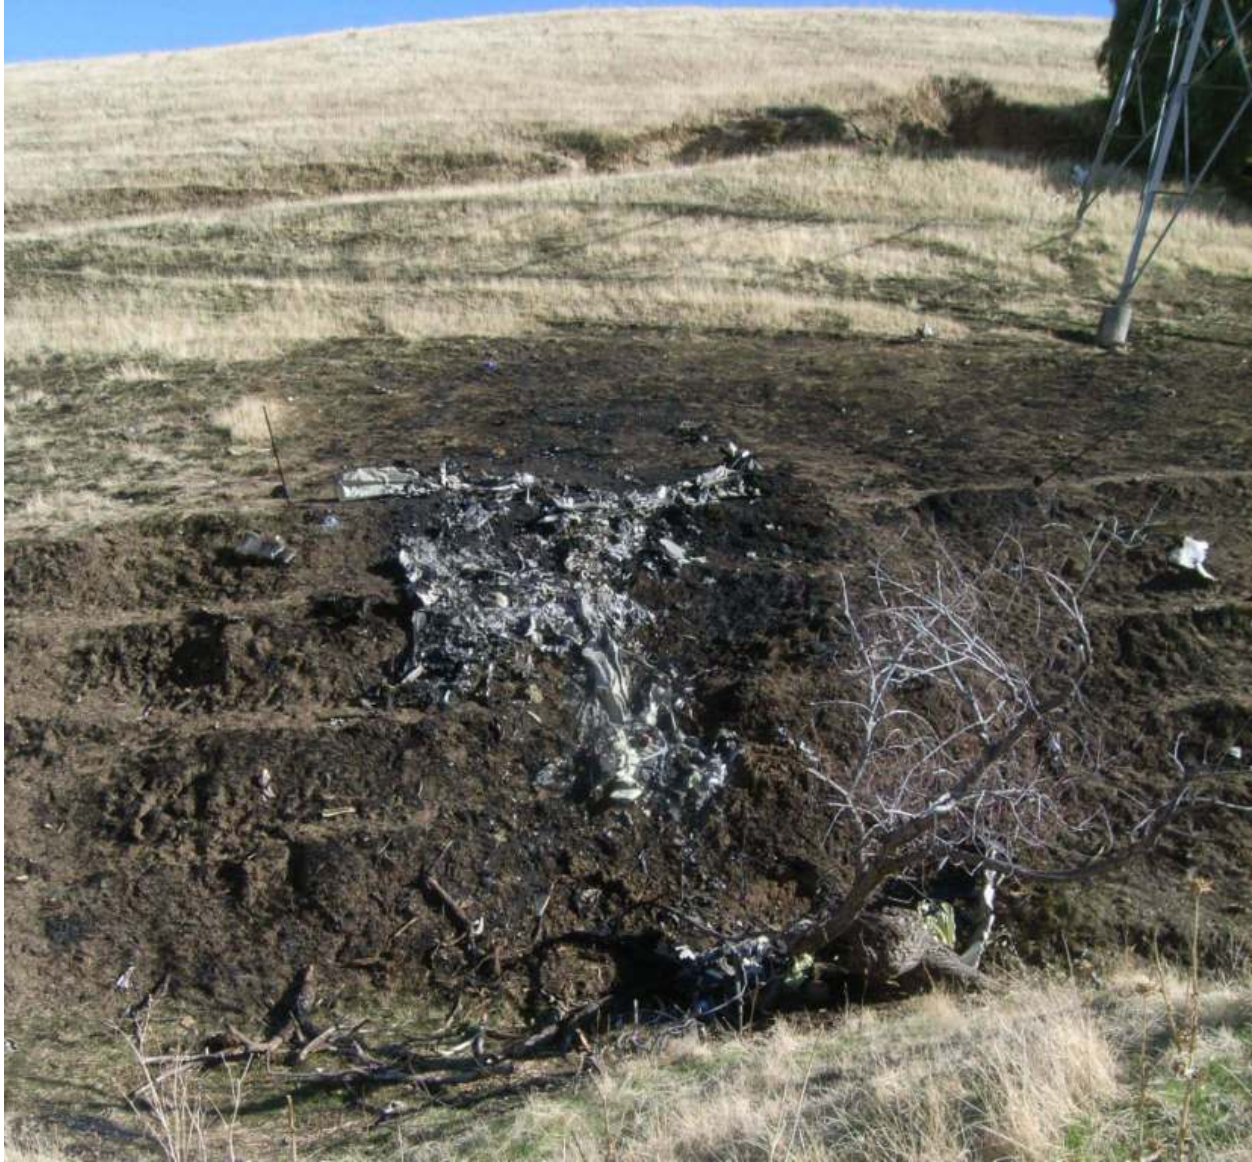
Figure 8 - Main Wreckage

- The terrain northeast of the ravine continued to slope uphill for several hundred feet
- The terrain southwest of the ravine rose gently for several hundred feet
- The main wreckage was very tightly contained, approximately within the area of a circle the diameter of the wing span
- Some debris, including the engine and a portion of the outboard left wing, was found at the bottom of the ravine
- Aside from the main wreckage impact area, only one additional ground scar was observed
 - That scar was situated about half way between the powerline strike and main wreckage locations
 - The scar was a divot in the ground that measured about 6" wide, 3' long, and 5" deep

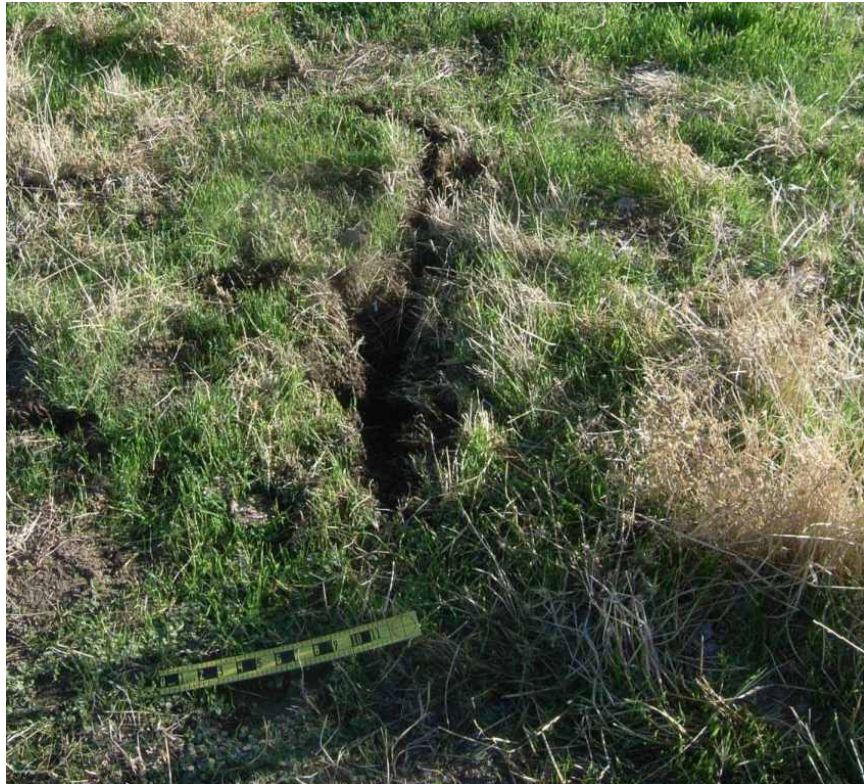
Figure 9 - Ground Scar Between Powerlines and Impact Site

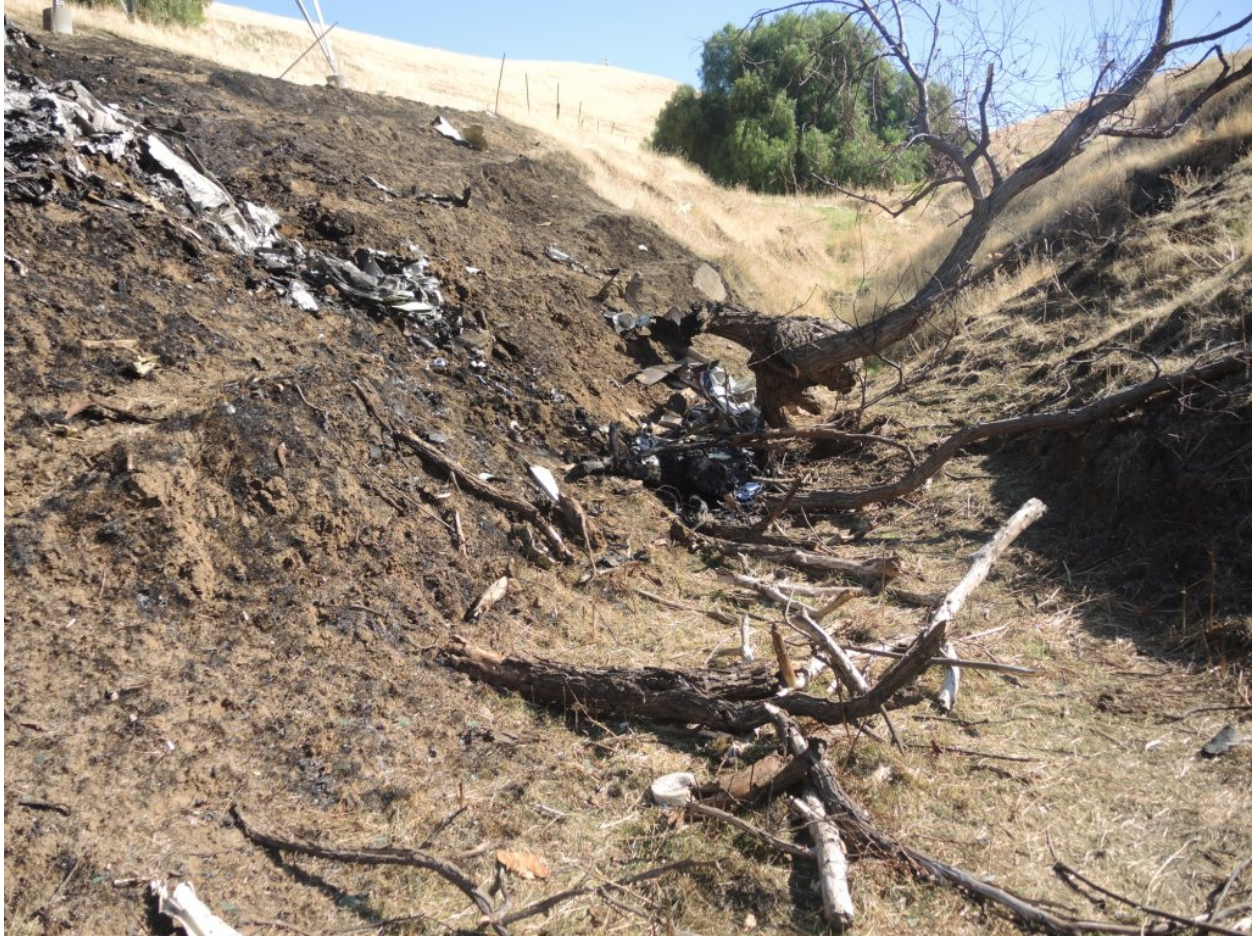
Figure 14 - Components in Ravine

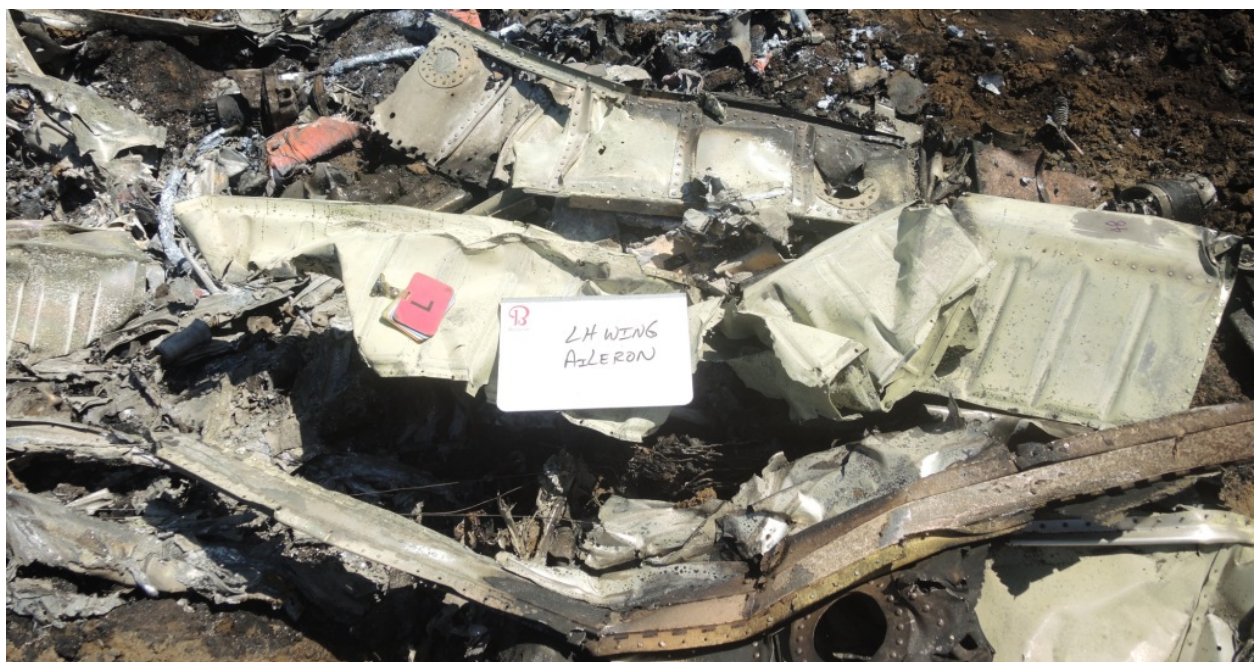
The left aileron remained attached to the left wing, but exhibited crushing, tearing, and thermal damage. The right aileron was fracture-separated from the right wing and exhibited crushing and tearing damage. The right aileron fragments were found in the debris field between the powerlines and the impact site, and exhibited no thermal damage. The aileron trim actuator (installed left side only) extension was measured to be 1 5/8 inches, which equates to about 4° left aileron TED.

Figure 15 - Left Aileron

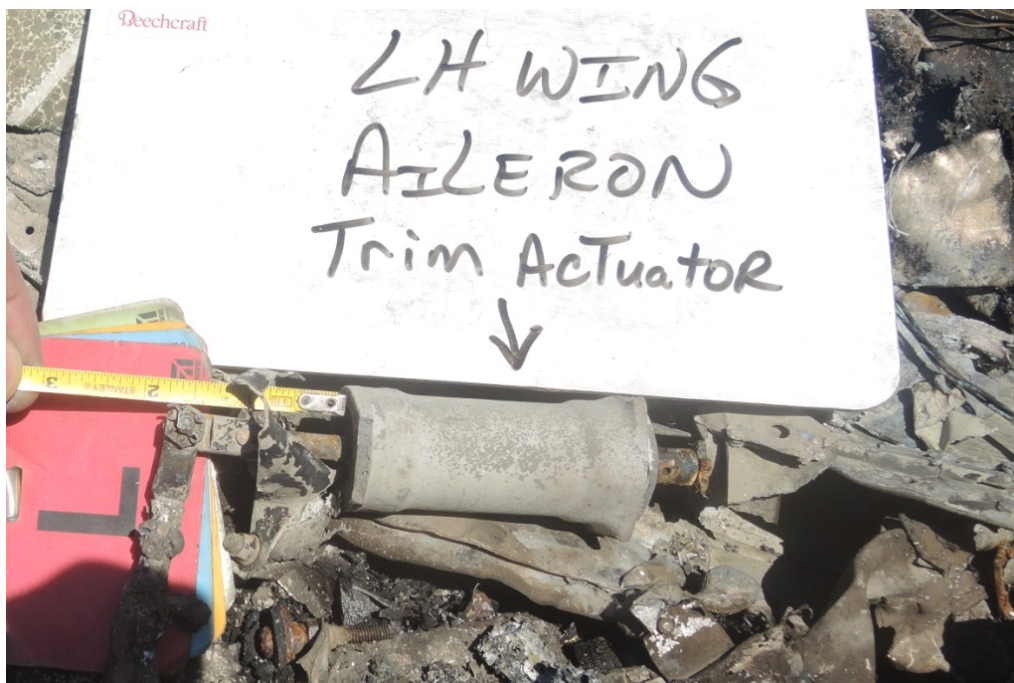
Figure 16 - Left Aileron Trim Actuator

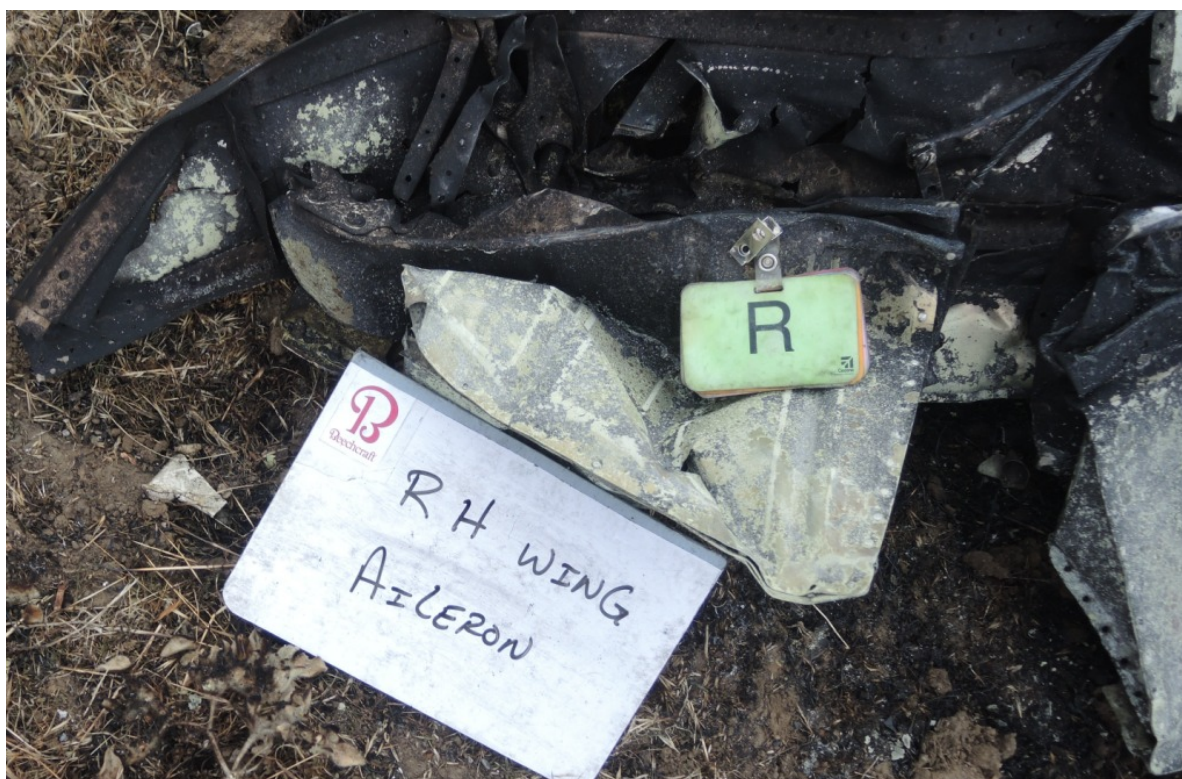
Figure 17 - Right Aileron

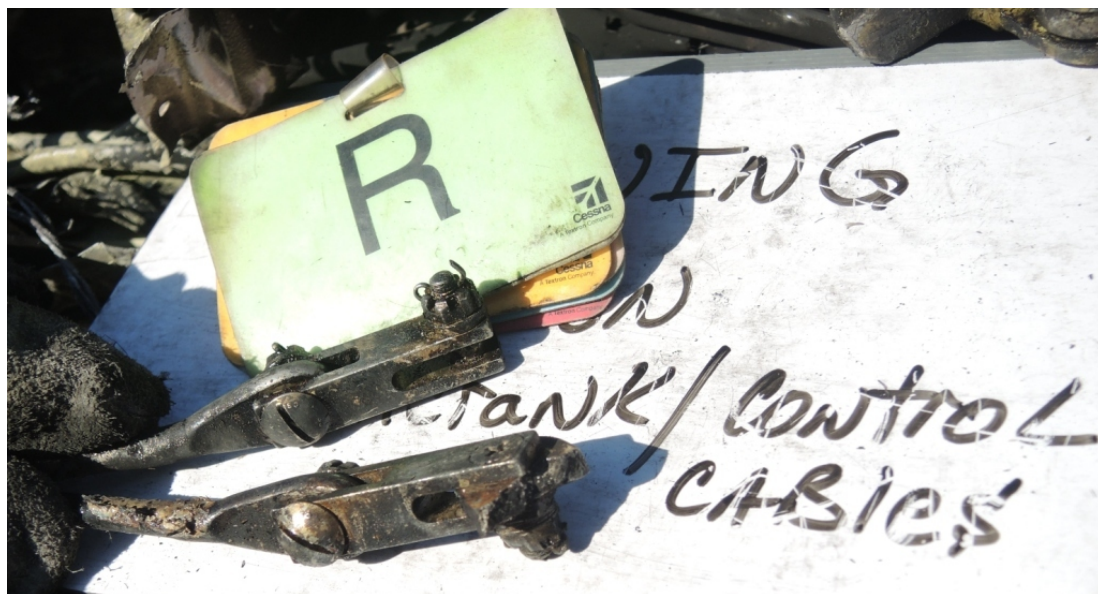
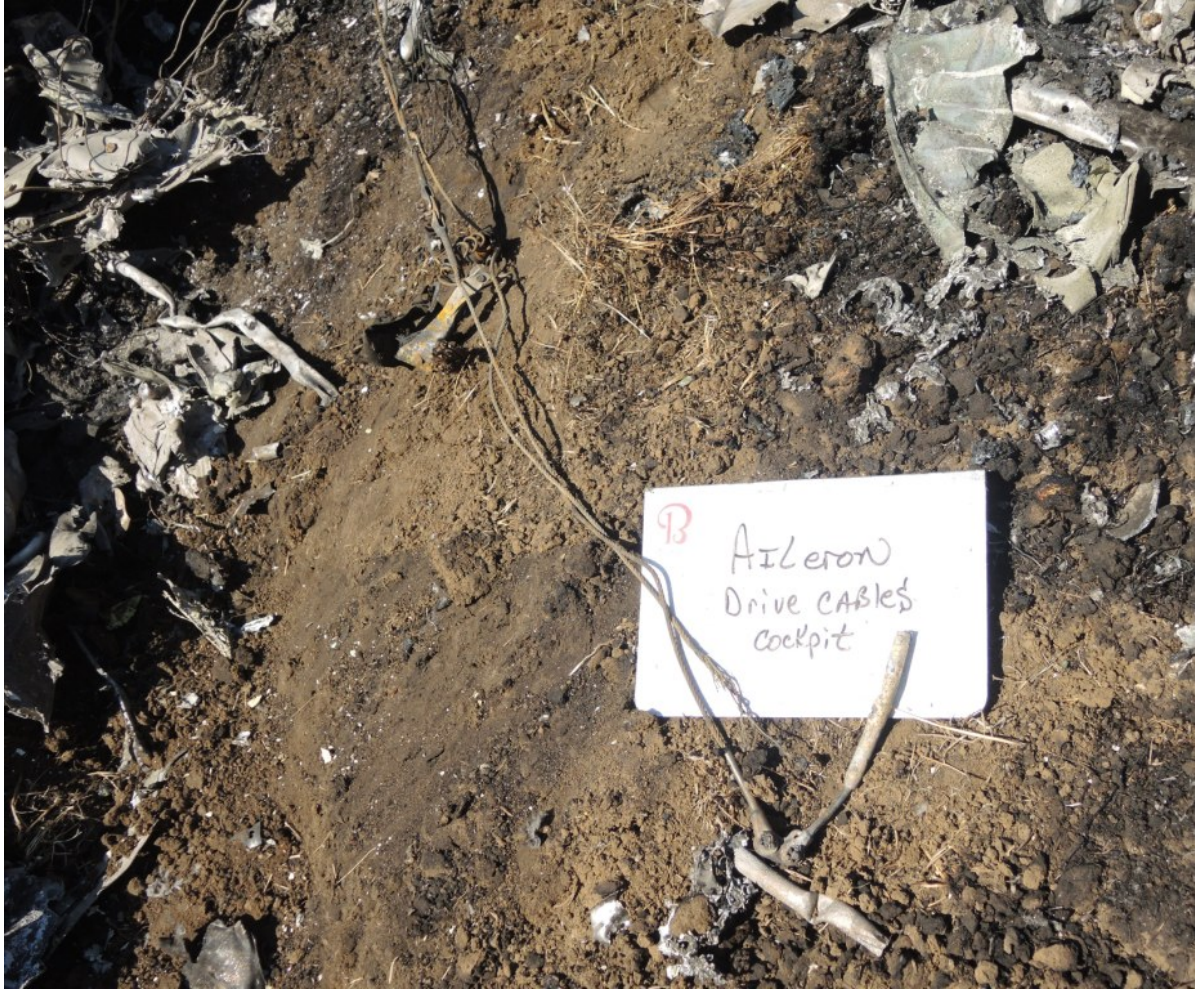
- Two cables consistent with the aileron drive ('up' direction) were observed to extend from the apparent remnants of their respective aileron bellcranks to the cockpit area.

- One aileron drive cable was fracture separated (consistent with tensile overload) near the cockpit area.
- A cable consistent with the aileron balance cable was identified. It was fracture-separated at about the mid-cabin location. The separation end fractures were consistent with tensile overload

Figure 19 - Aileron Cables

Figure 20 - Aileron Cables

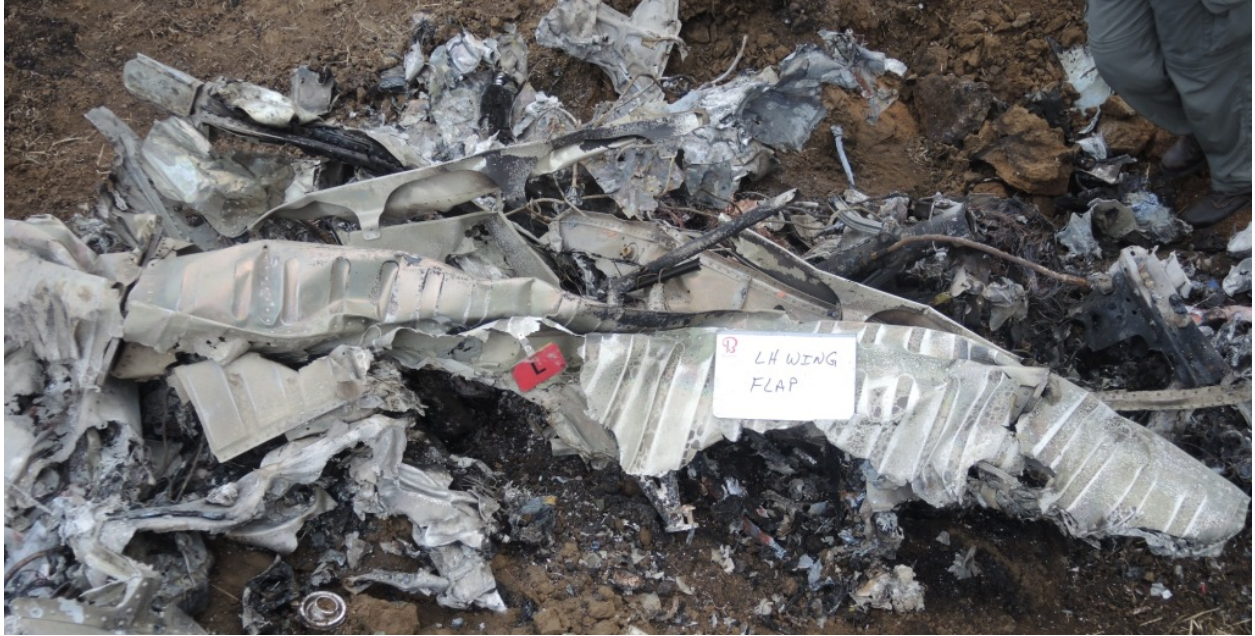
Both flaps remained partially attached to their respective wings; all components were severely disrupted by impact and damaged/consumed by fire. Relative flap-wing positions were consistent with flaps retracted at impact. The left flap actuator extension was measured to be about 1 ½ inches, which equates to a flap extension of 0° (flaps up/retracted). No measurement was obtained from the right wing flap actuator due to impact damage.

Figure 22 - Left Wing Flap

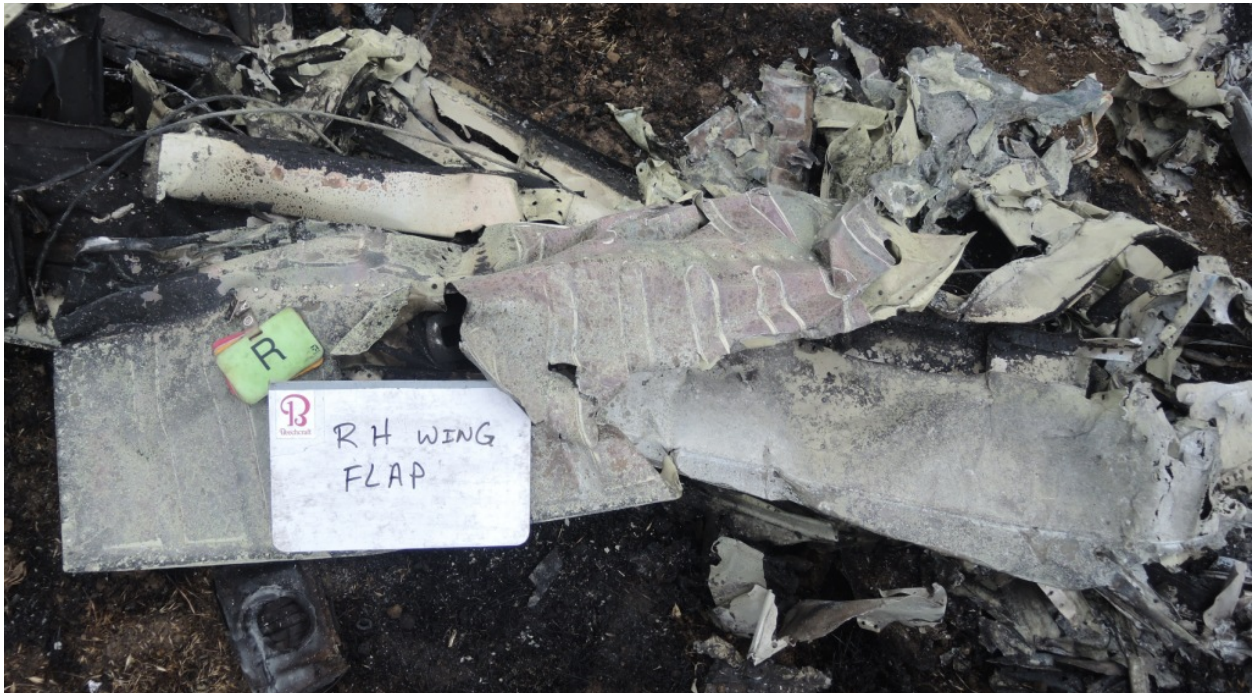
Figure 23 - Right Wing Flap

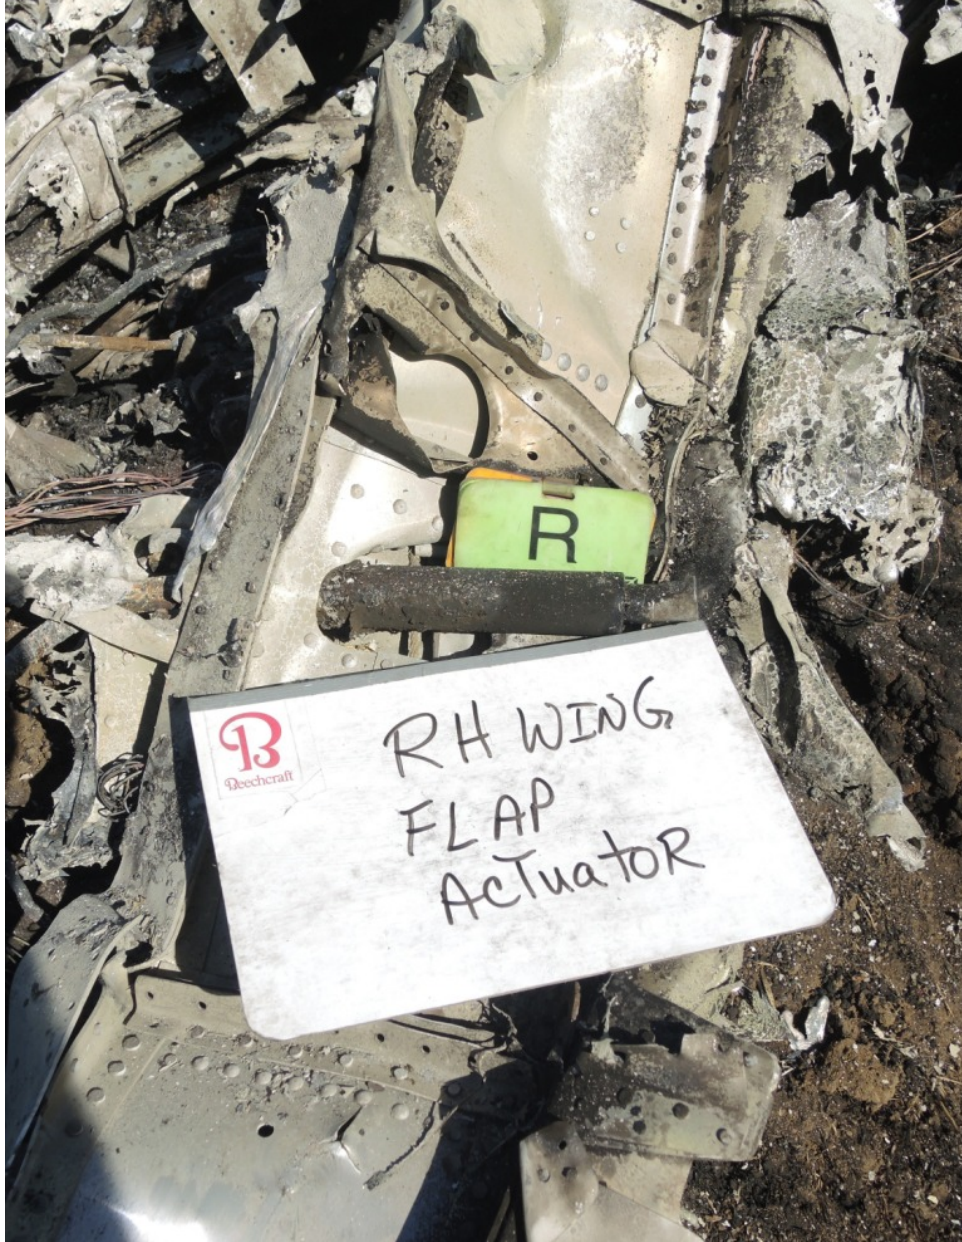
Figure 24 - Right Flap Actuator

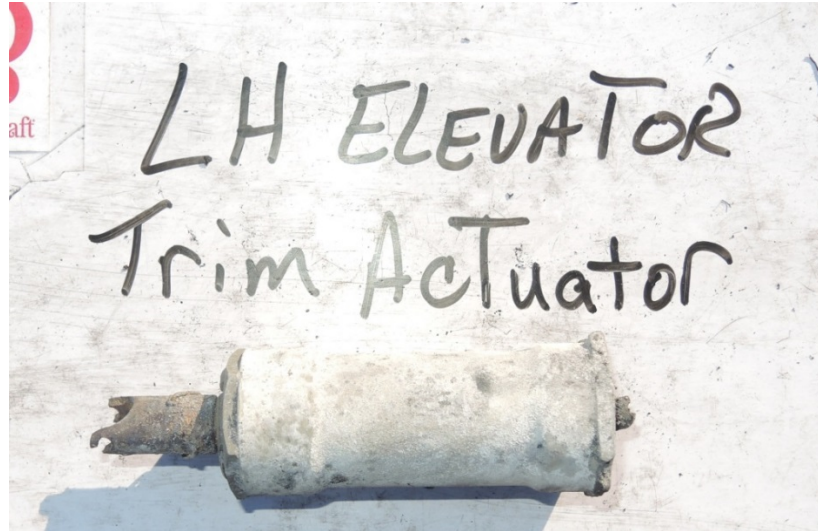
The left and right elevators were fracture-separated from their respective horizontal stabilizers, and were also torn/cut into several pieces. The elevator fragments were almost all found in the debris field between the powerlines and the impact site, and those pieces exhibited no thermal damage. No measurements of the left and right elevator trim actuators were possible due to impact and/or thermal damage.

Figure 27 - Left Elevator Trim Actuator

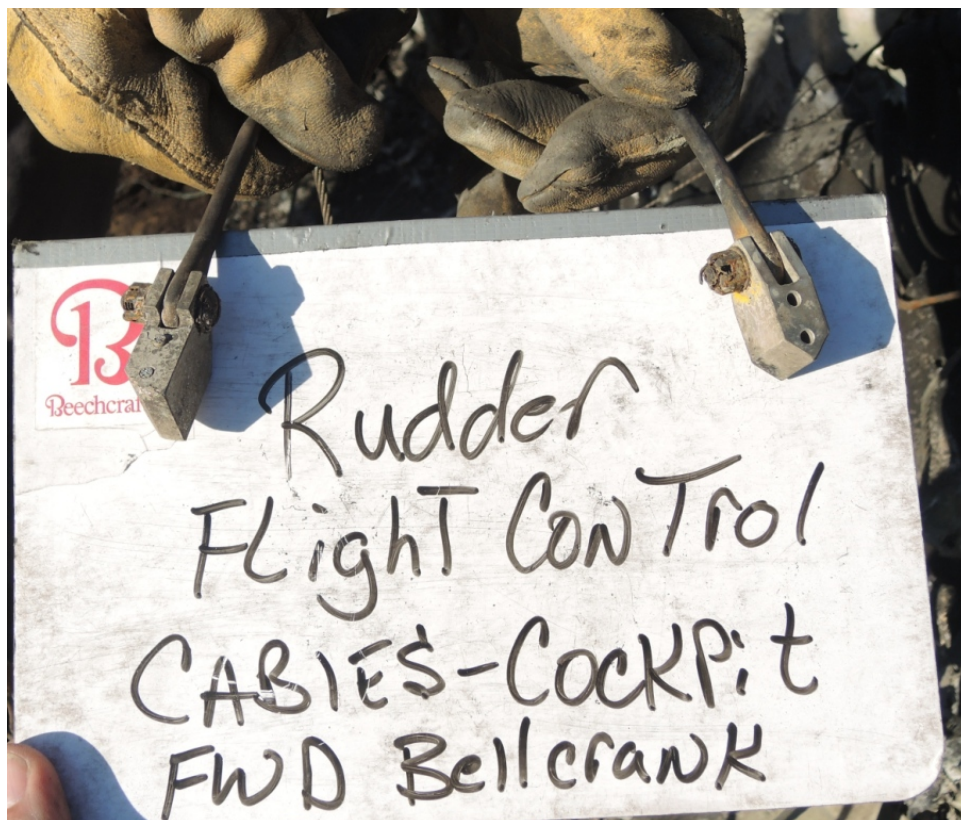
- The right rudder cable was continuous throughout its length
 - The left rudder cable exhibited a fracture separation consistent with tensile overload, about 3 feet forward of the rudder aft bellcrank

Figure 28 - Rudder Cables

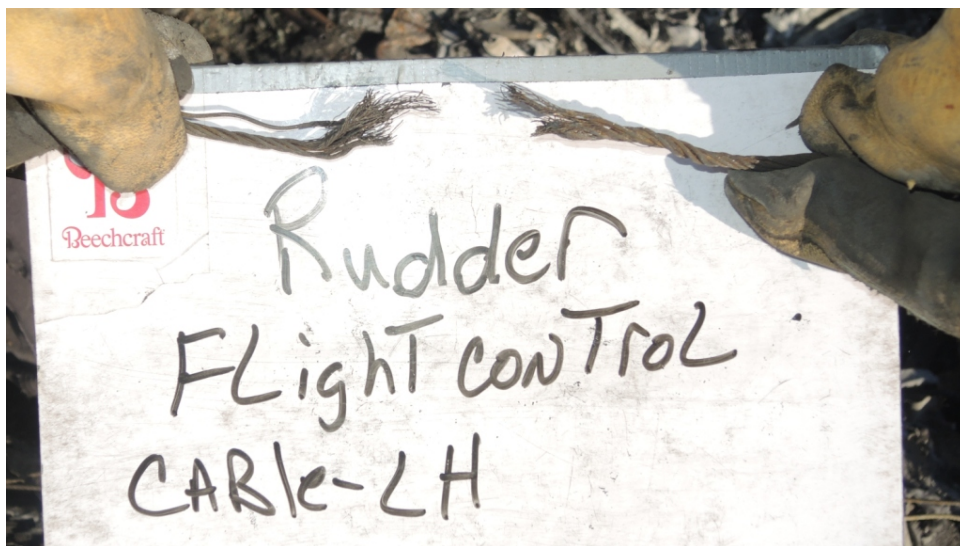
Figure 30 - Left Rudder Cable

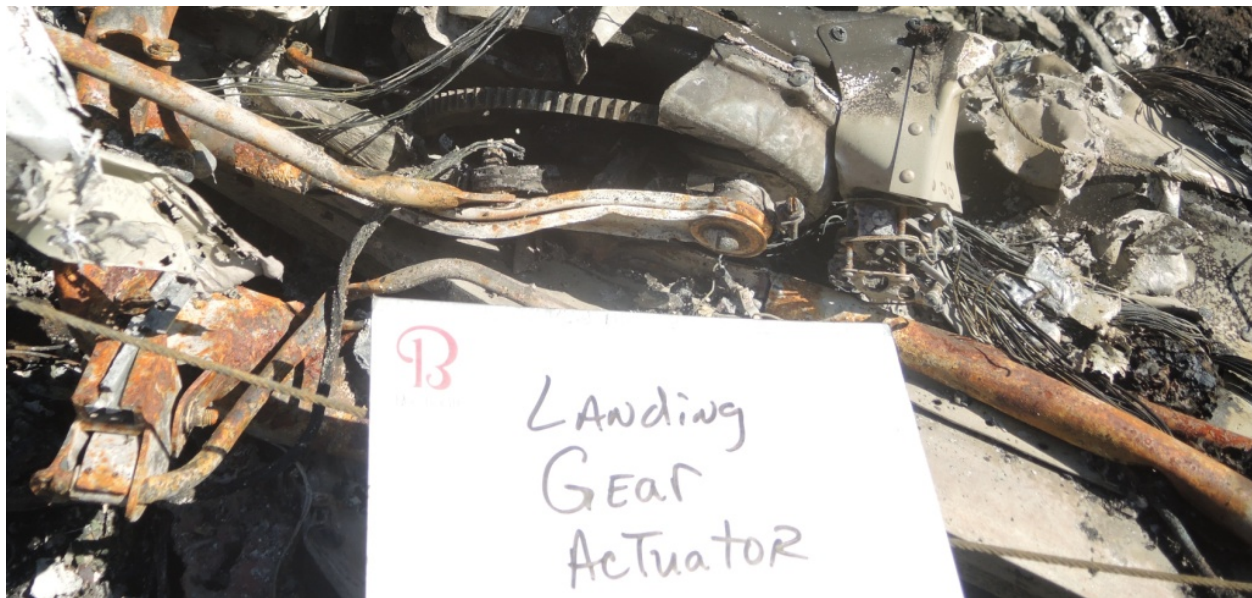
The landing gear cockpit controls and indicators, and most landing gear components, sustained significant impact and/or thermal damage, and yielded almost no useful information. However, both the nose and main landing gear actuator configurations were consistent with the landing gear being retracted at the time of impact.

Figure 31 - Landing Gear Actuator

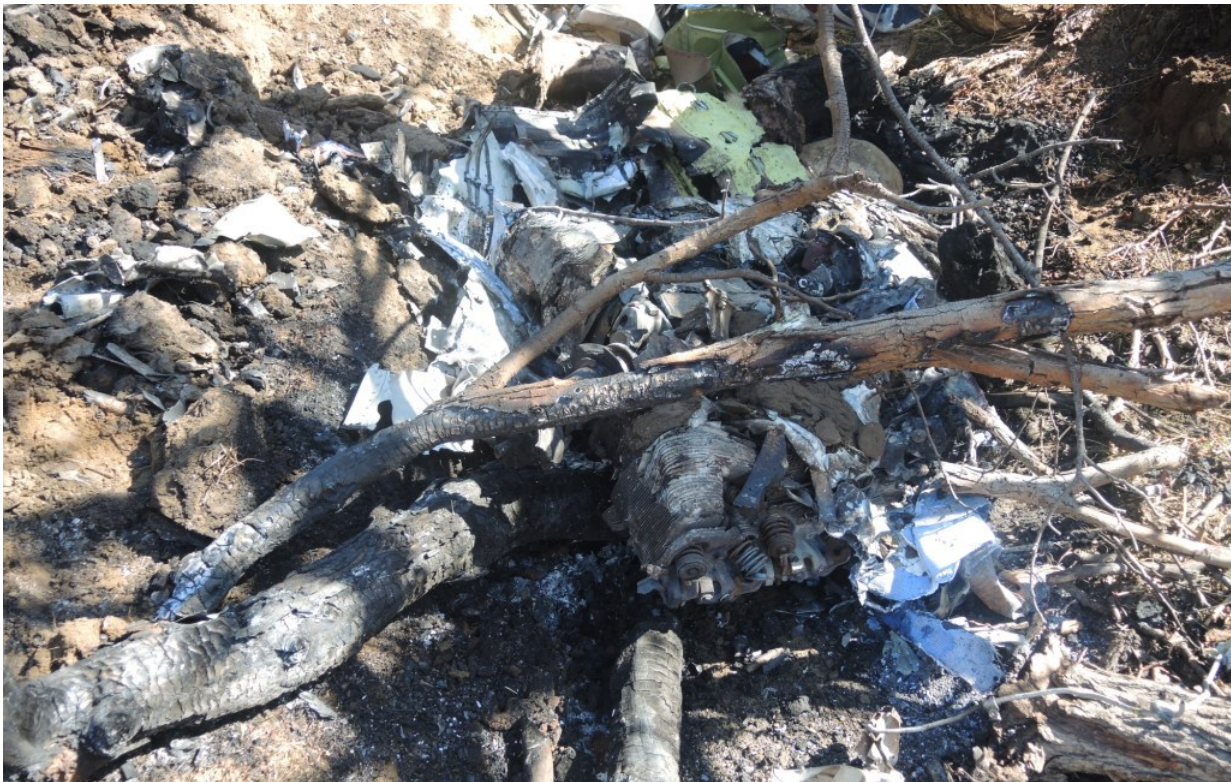
- The engine was located at the bottom of the ravine, about 15 feet downslope of where it impacted (based on propeller witness marks in the soil)
- The engine sustained significant impact damage, and thermal damage consistent with the post impact fire

- The crankcase was fractured, the crankshaft was bent, and the propeller was fracture-separated from the engine
- Most accessories were fracture-separated from the engine

- No evidence of any pre-impact engine or engine component failures was observed
- No direct information regarding the engine functionality or operational status was able to be determined

Figure 32 - Engine

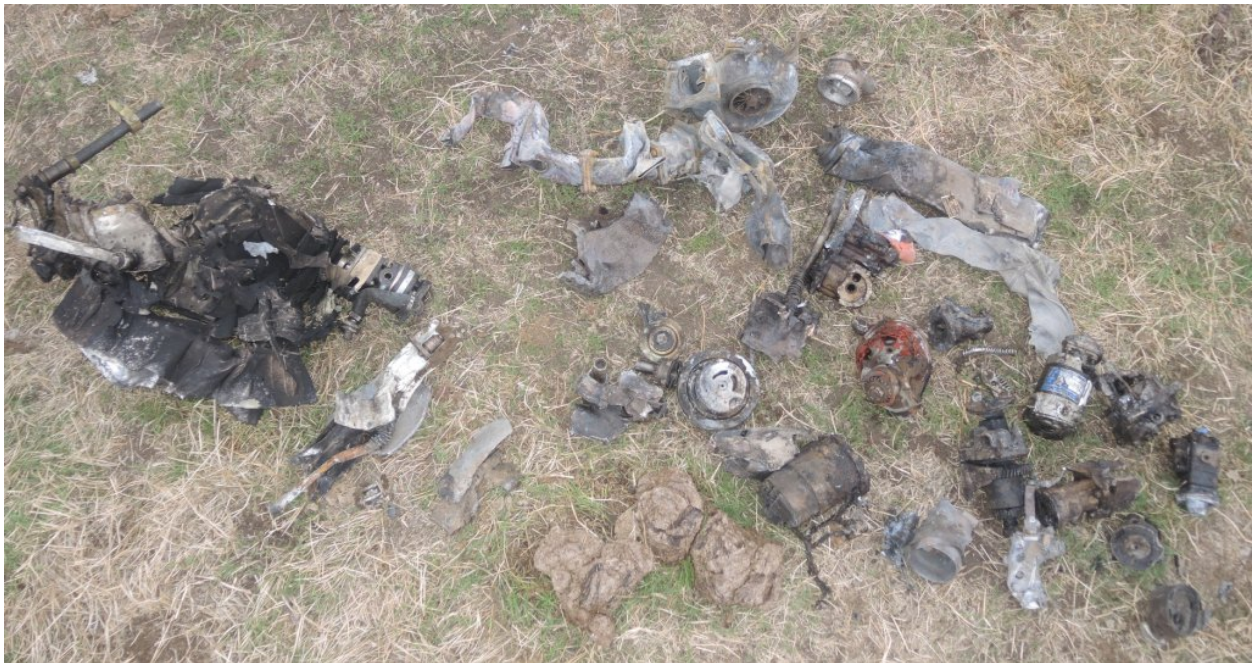
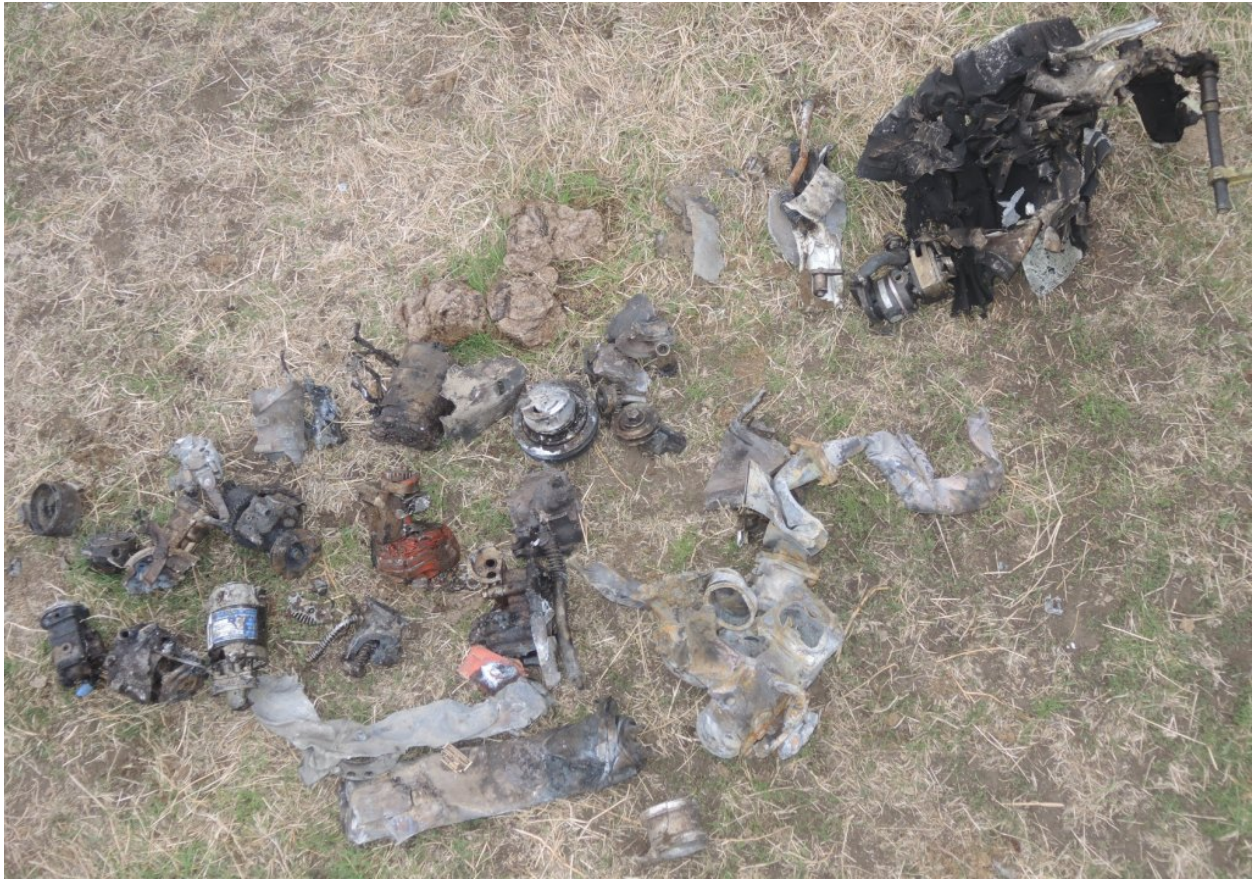
- All sustained severe impact damage
 - Most also sustained thermal damage consistent with a post impact fire
 - No information regarding the integrity, functionality, or operational status of any of those accessories was able to be determined.

Figure 34 - Engine Accessories

Figure 35 - Engine Accessories
